**University of Hull Photovoltaic
Project, Snuff Mill Lane – BS
5837:2012 Arboricultural
Report, Impact Assessment
and Method Statement
Gardiner and Theobald LLP**

Report Title: University of Hull Photovoltaic Project, Snuff Mill Lane –
 BS5837:2012 Tree Survey, Arboricultural Impact Assessment
 and Arboricultural Method Statement

Version: V2.0
Issue Date: September 2022
Report Ref: 18618D

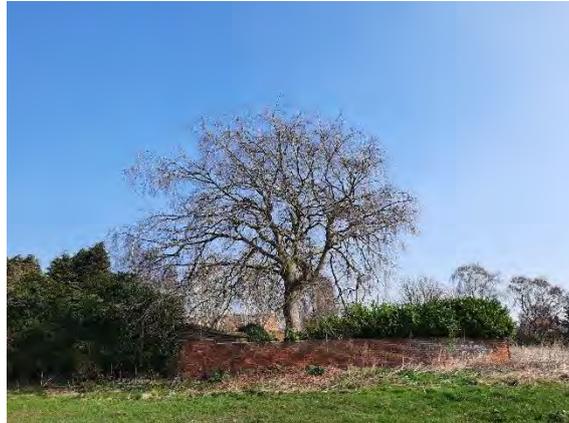
Plate 2: T014 from the west

- 4.5.1 Where proposed operations encroach beneath the canopy or into the RPA of retained trees there is the potential for damage to occur.
- 4.5.2 Installation of boundary fencing is proposed within the RPA of the retained trees T014 and G023.
- 4.5.3 Potential impacts to tree roots can often be overcome through the use of fencing that requires minimal excavations.
- 4.5.4 Installation of the solar panels will encroach into the rooting area of T020. This is deemed acceptable as will be a minimal encroachment and the panels will be installed in a similar method that of fencing post.
- 4.5.5 All works within the RPA or beneath the canopy of retained trees should be detailed as part of an Arboricultural Method Statement to ensure that these works are carried out in a manner that eliminates the likelihood of any damage occurring.

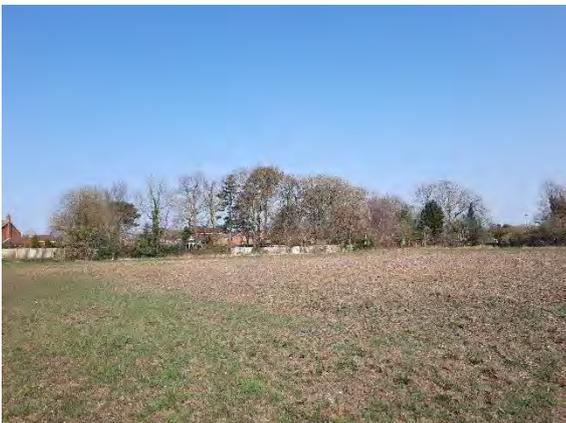
Plate 3: G025 and G026 from the south west

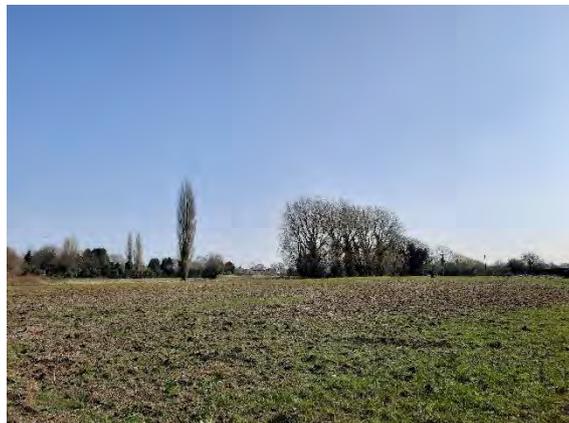
- 3.2.4 The largest trees growing within the site boundaries were the groups G022, G023 and G029. These trees were visually prominent and in keeping with the surrounding landscape character, however some of the trees may have limited longer term value due to their condition or species characteristics.

Plate 4: T020, T021, G022 and G023 from the west

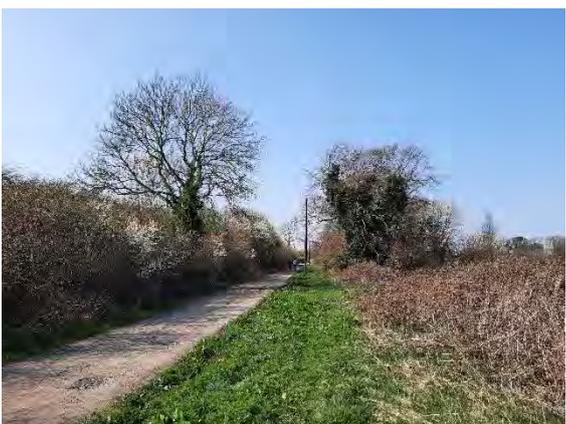
Plate 5: H028 and G029 from the east

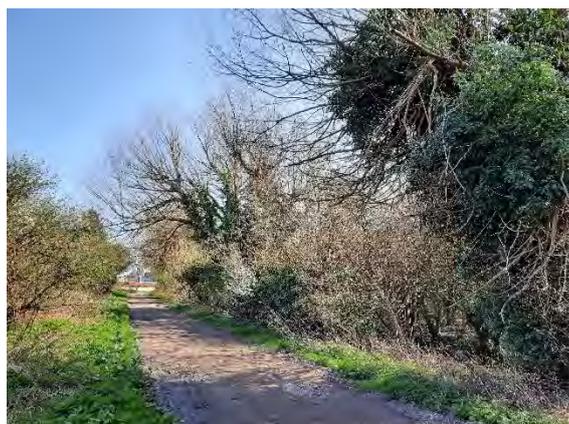
- 3.2.6 To the south east of the site was the group of elm trees, G035. The trees within this group were in a particularly poor condition and large limbs failures are likely in the short term. Due to their proximity to a well-used footpath and driveway it is recommended that these trees are removed to ground level as soon as is reasonably practicable.

Plate 6: G035 from the north west
